FLOOD RISK FROM DANGEROUS DAMS IN BULGARIA

Abstract: This study aims to evaluate the condition of small dams in Bulgaria and analyse the challenges in managing small dam flood risk. After the bursting of two small dams caused devastating deadly floods in the town of Tsar Kaloyan in 2007 and in village of Biser in 2012, public sensitivity to the safety of such facilities greatly increased. A number of administrative measures have been taken to improve the management of small dams and increase their security, but many of the problems remain unresolved. A methodical approach to managing flood risk from small dams requires concerted action between activities aimed at enhancing the safety of the dams themselves, managing river basin flood risk, and managing flood risk in riparian settlements. In this study, we analyse the factors that increase the threat of and vulnerability to such disasters, using the floods in Tsar Kaloyan and v. Biser as case studies. The results demonstrate a need to link more closely flood risk management plans in river basins to those in settlements, and to ensure they factor in the geographical characteristics of the territory and the impacts of climate change.

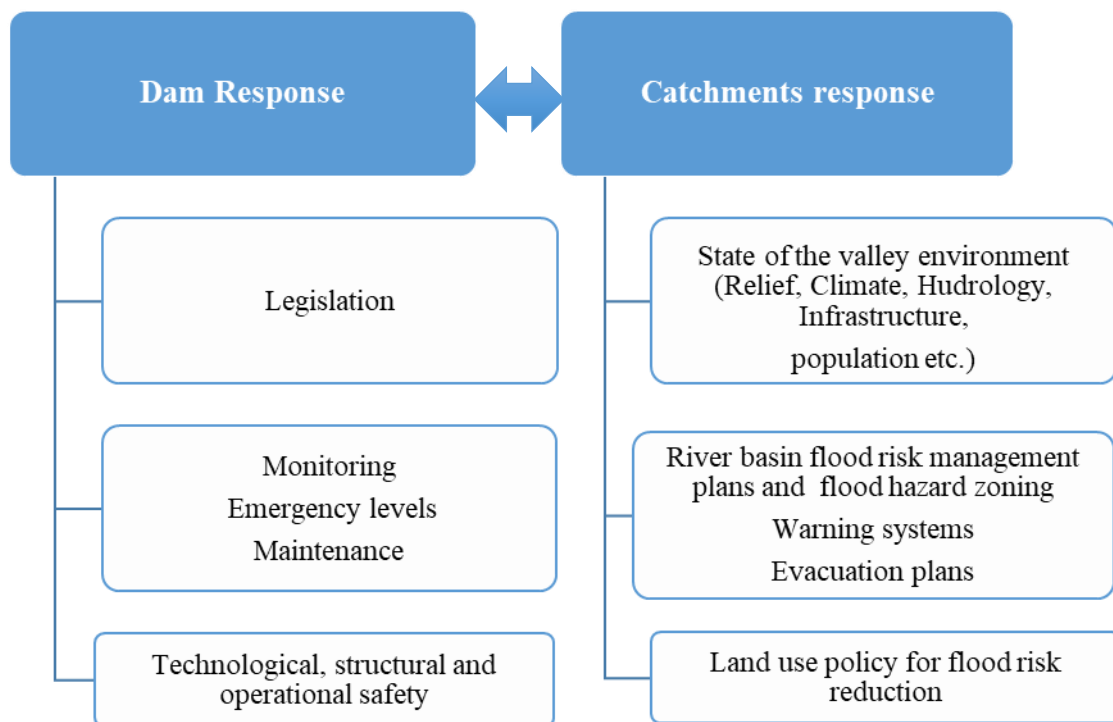
Fig.1. Dam-catchments flood hazard response indicators – after [4]

Dam hazard management and risk reduction are analyzed in the context of existing legal and operational safety regulations and management at the time of the disaster events. The catchment disaster response is analyzed on the basis of the geographical characterization of the affected catchments and settlements from two particular devastating flood events caused by small dams breaking. The dam response depends mainly on technological and structural operational safety, their monitoring and maintenance according to the level of emergency. The catchment response may accelerate or reduce the flood risk hazard. That is why it is important to implement an integrated flood management approach for both the catchments and the adjacent small dams (Fig. 1).

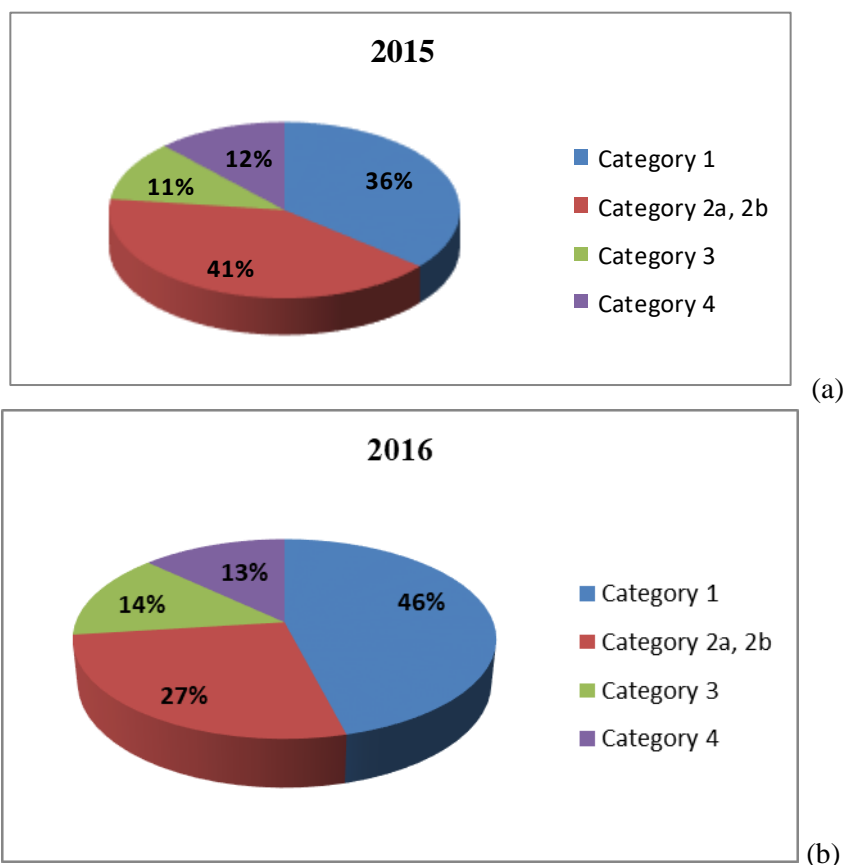
Fig. 2. Relative share of each hazard category for inspected dams in 2015 (a) and 2016 (b)

2a, 2b, 3 and 4 in 2015 was 482 (59,95% of all inspected dams), and in 2016 it was 340 (54,4%). Fig.2 (a and b) illustrate the distribution of the relative share of each category for the years 2015 and 2016. The results show that dangerous dams of categories 2, 3 and 4 predominate, with 64% of all dams examined in 2015 and 54% in 2016. The distribution of hazardous dams of all categories (2a, 2b, 3 and 4) by districts shows that the problem with dam safety is biggest in districts of Pleven, Plovdiv, Stara Zagora, Pazardzhik and Burgas, which have more small dams due to their flat relief with intensive agriculture and need for irrigation (Fig. 3). The data show that in 2015, there were 91 small dams in pre-emergency state in 54 municipalities in the country (Fig. 4).
